Somali Regional State

Environmental Protection and Rural Land Administration Bureau

10/8/2021

Environmental and Social Performance Audit Report on Asphalt Roads (four subprojects)

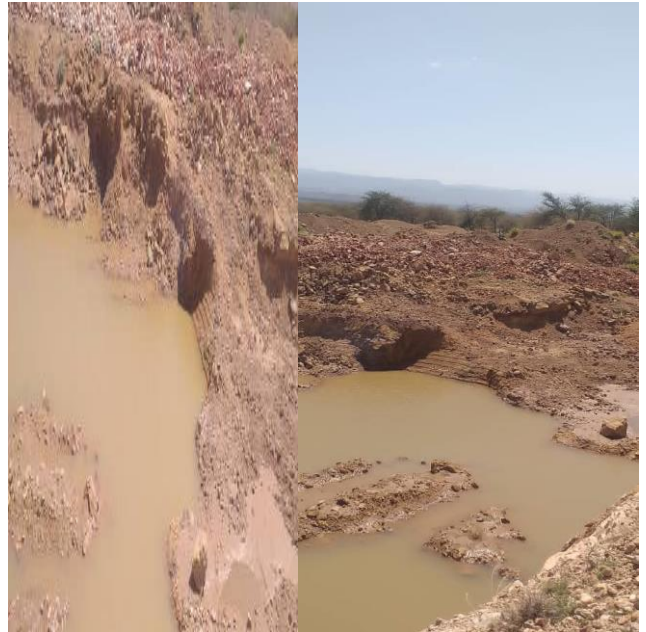
- Close/ opening pits/quarry sites during construction and that may have a risk/death for the community or livestock around the projects
- Construct any drainage which affect agricultural land
- Compensate local community for their agricultural land and grazing land
- Construct the infrastructure with the required standard quality
- Construct culverts across road junctions
- Environmental rehabilitation
- To participate community development

Picture 1. Opening pits with unsafe water

- The Implementing Company is recommended to implement all non-complied construction activities mentioned above under 4.5.1.2. As per the agreement made during the ESPA closing discussion and complete the remaining work.

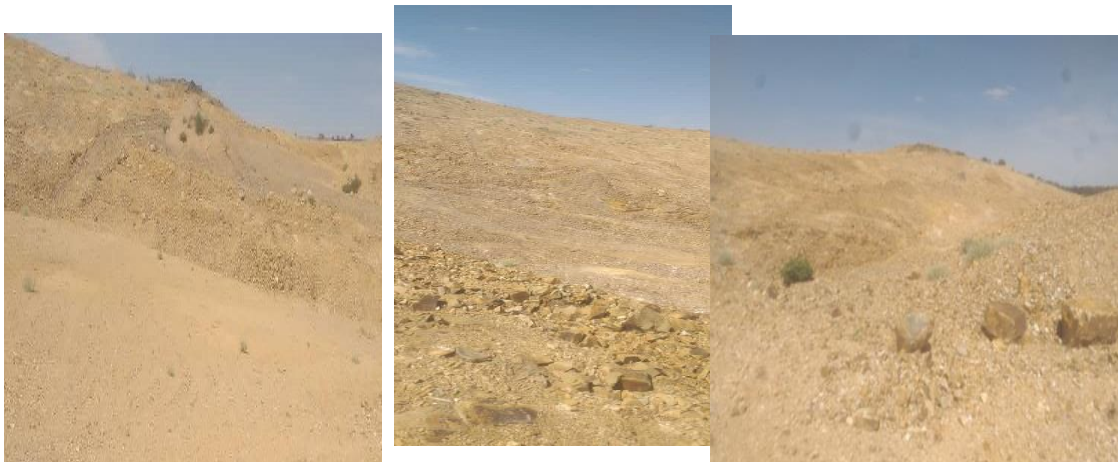
Picture . Mining sites during asphalt construction but remained degraded land

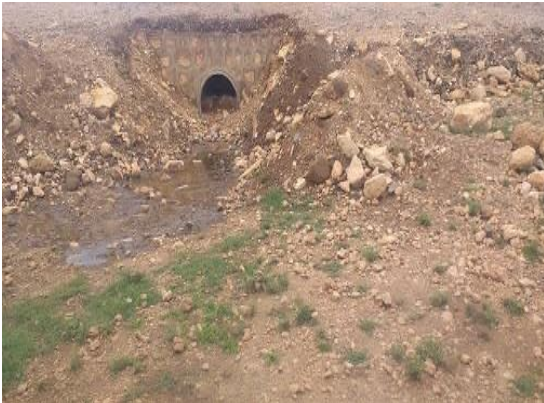
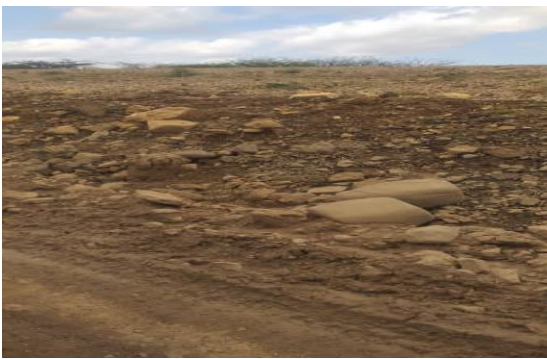
Picture 2: cart way and closing ditch

Despite this, the asphalt road Implementing Company (YOTEK) was failed to comply the following mitigation measures **Crossing slabs construction**: crossing slabs were not enough constructed side to side.

- **Completion of project**: the asphalt road and closed ditch project was not completed (under construction).
- **Cart away**: the excavated soil and excess materials were disposed on the sides and this have a risk for community and livestock even road.
- **Culvert construction**: it was not aliened to closed ditch. Around some parts the drainage constructed by closed ditch. It was open at risk situation.
- **Poles**: the transformer pole were not avoid from the road.
- **Ford**: the road was not constructed with ford around the steep area and on the side

- The asphalt road Implementing Company (YOTEK) is recommended to implement all non-complied construction activities mentioned above under 4.5.1.2. As per the agreement made during the ESPA closing discussion and complete the remaining work in as per planed.

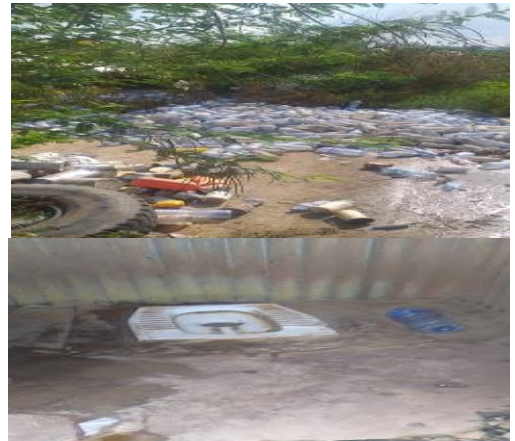
- To Rehabilitation for degraded land which contribute global warming(climate change) and air pollution for the local communities
- To participate community development
- To Management of solid and liquid waste
- Unsafe occupational health for workers in both dorm and outside the room

Picture 2: unsafe toilet and open landfill inside the compound

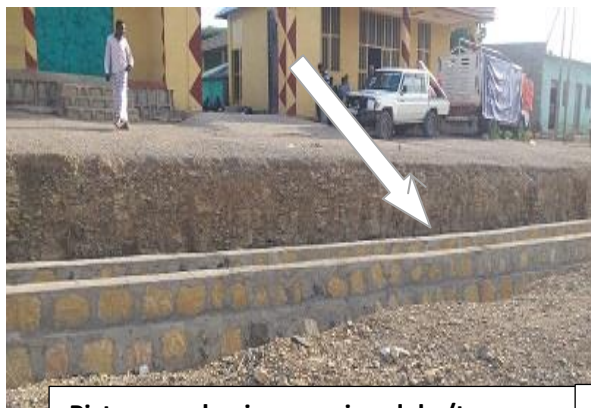
- Construct crossing slabs across the ditch;
- Construct water inlets to the ditch with appropriate degree
- Remove the construction cart away from the project site or reused for backfill and land levelling
- Connect the drainage ditch with natural water way or existing drainage ditch
- Construct the infrastructure with the required standard quality
- compensate the demolition of the houses in the fik town
- To Rehabilitation for degraded land which contribute global warming(climate change) and air pollution for the local communities
- To participate community development
- To Management of solid and liquid waste

Picture: no having crossing slabs/taps

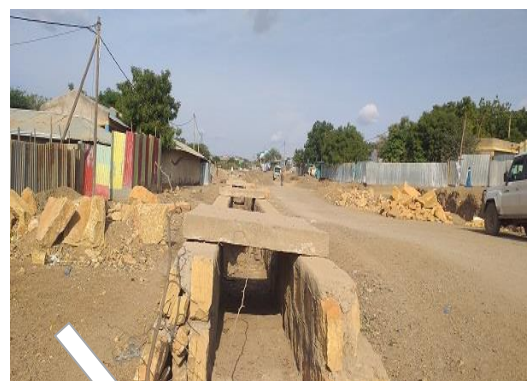
Picture: not remove cart ways from the project
